INDOOR AIR QUALITY ASSESSMENT

**Memorial Elementary School
2 Fiske Avenue
Upton, Massachusetts**

Prepared by:
Massachusetts Department of Public Health
Bureau of Environmental Health Assessment
June, 2001

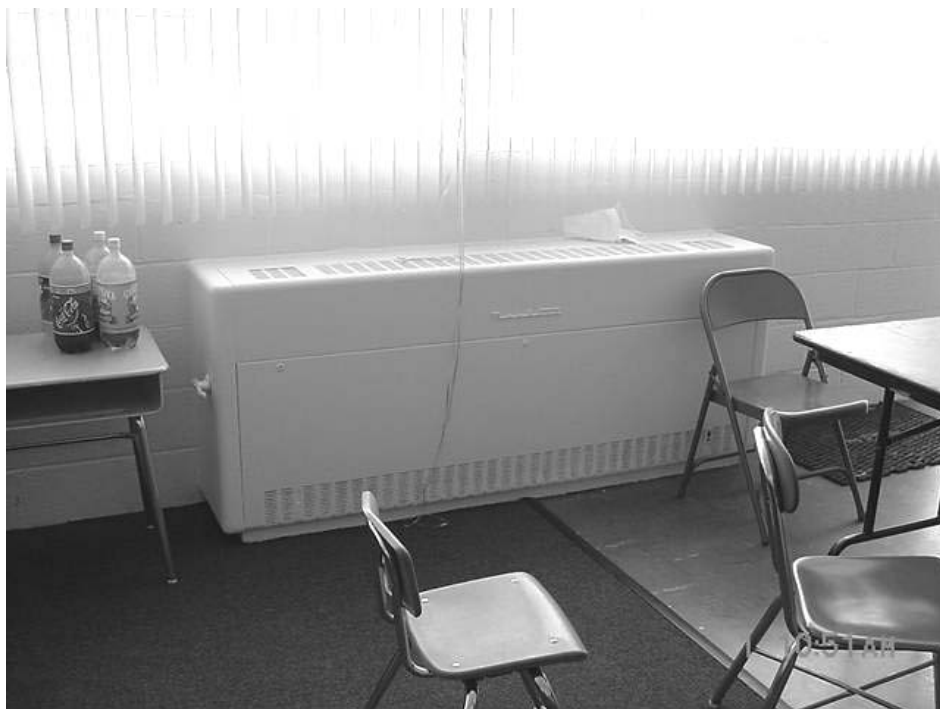
Picture 2

Fresh air in classrooms is supplied by a unit ventilator (univent) system (see Pictures 2 & 3). Univents draw air from outdoors through a fresh air intake located on the exterior walls of the building (see Picture 4) and return air through an air intake located at the base of each unit ([see Figure 1](#)). Fresh air and return air are mixed, filtered, heated and provided to classrooms through a fresh air diffuser located in the top of the unit. The opening of fresh air dampers can be controlled manually by the use of a lever located on the side of each unit (see Picture 5). It should be noted that univents were installed during the original construction, which would make them approximately forty to fifty years old. All univents were operable and appeared to be well maintained. Most of the univents were deactivated during the assessment, but were reactivated by Mr. Choiniere so BEHA staff could observe operation.

Classroom Univent in Original Wing

1. To maximize air exchange, the BEHA recommends that both supply and exhaust ventilation operate continuously during periods of school occupancy. Adjust manual intake levers on univents to increase the percentage of fresh air intake if necessary.

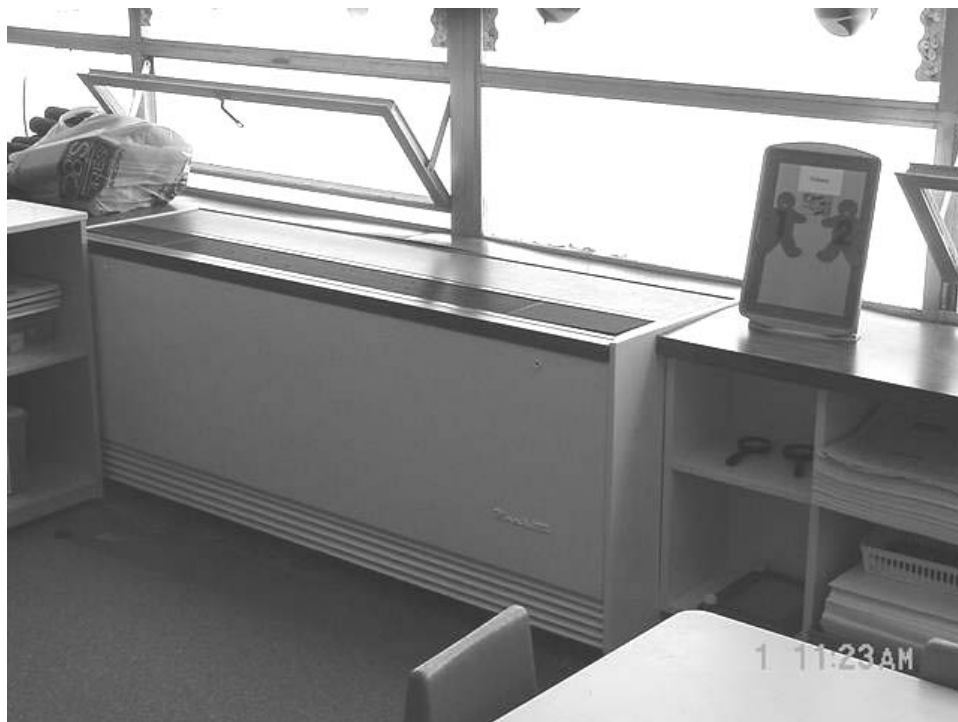
Picture 3

Classroom Univent in 1956 Addition

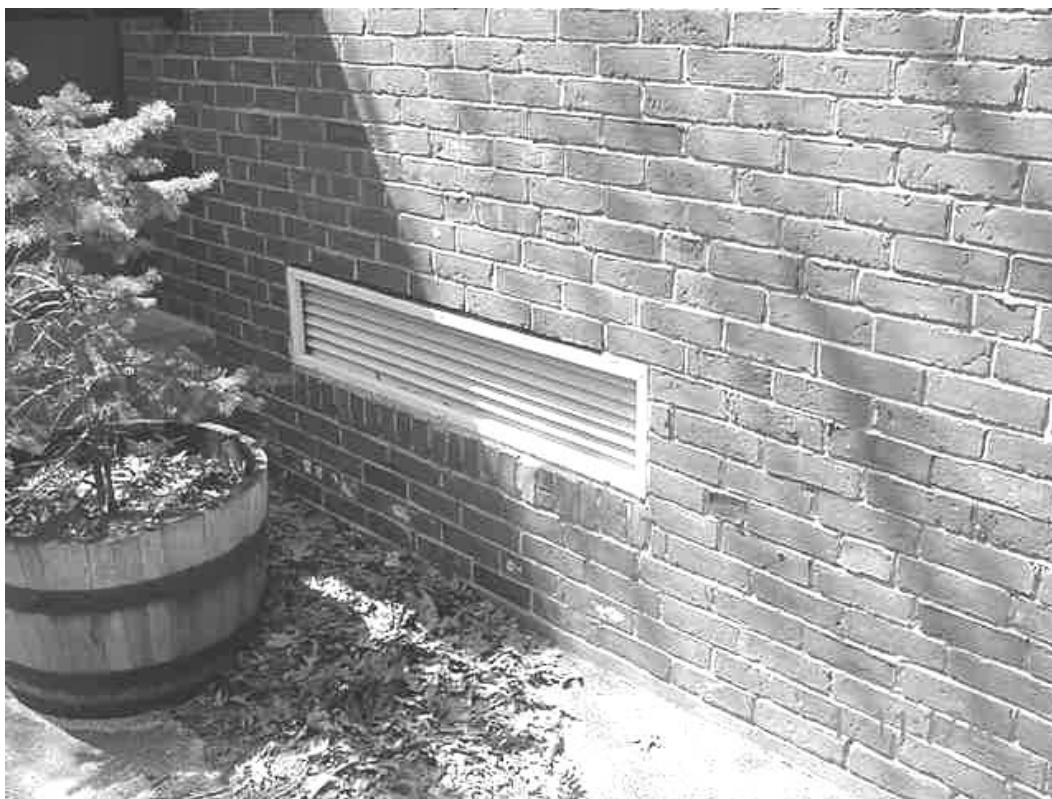
Picture 4

Univent Fresh Air Intake on Exterior of Building

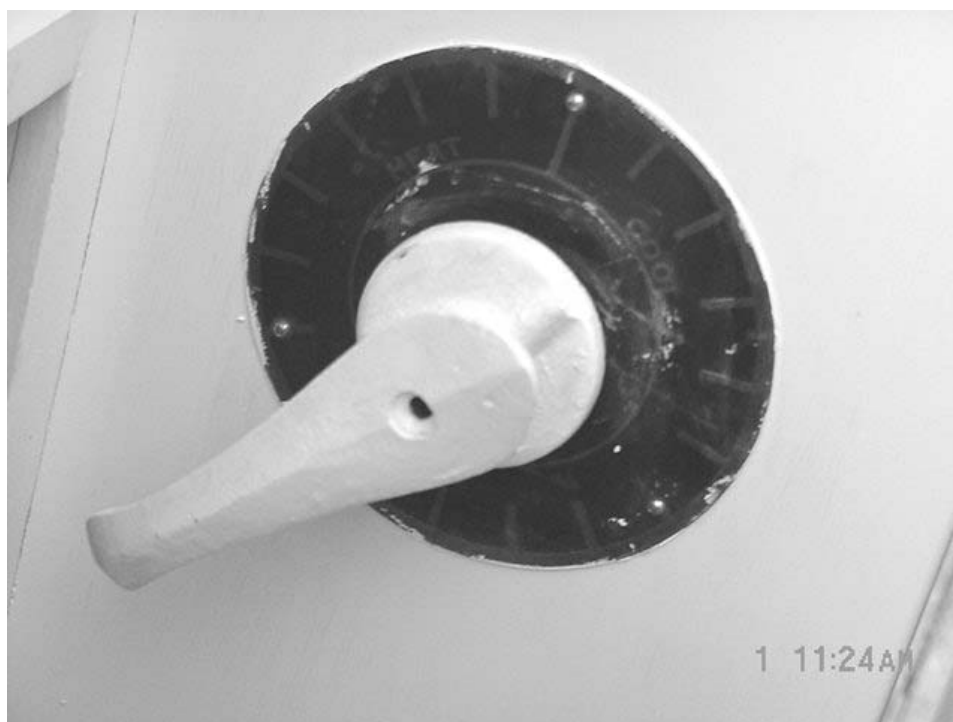
Picture 5

Manual Control to Adjust Fresh Air Dampers in Classroom Univents

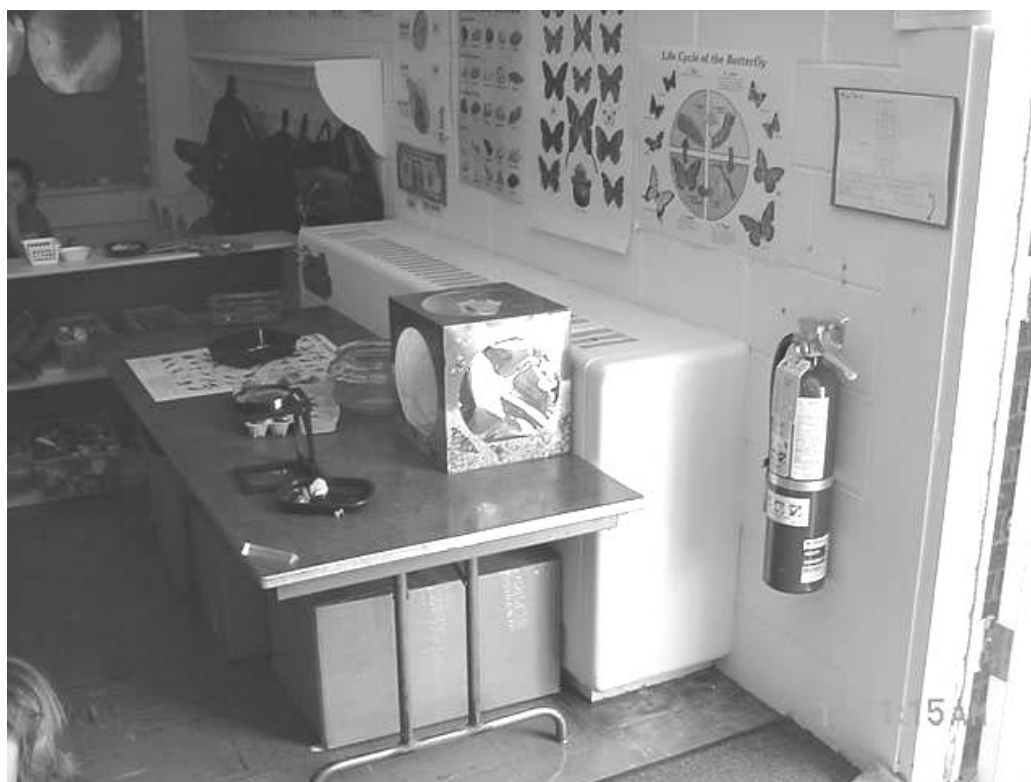
Picture 6

Obstructions to airflow, such as items placed in front of univent returns, were seen in a few classrooms (see Picture 6). To function as designed, univents and univent returns must remain free of obstructions. Importantly, these units must be activated and allowed to operate during hours of school occupation.

Univent Return Vent (Front) Obstructed by Boxes and Other Items

4. Remove all obstructions from univents and mechanical exhaust vents to facilitate airflow.
5. For buildings in New England, periods of low relative humidity during the winter are often unavoidable. Therefore, scrupulous cleaning practices should be adopted to minimize common indoor air contaminants whose irritant effects can be enhanced when the relative humidity is low. To control for dusts, a HEPA filter equipped vacuum cleaner in conjunction with wet wiping of all surfaces is recommended. Drinking water during the day can help ease some symptoms associated with a dry environment (throat and sinus irritations).

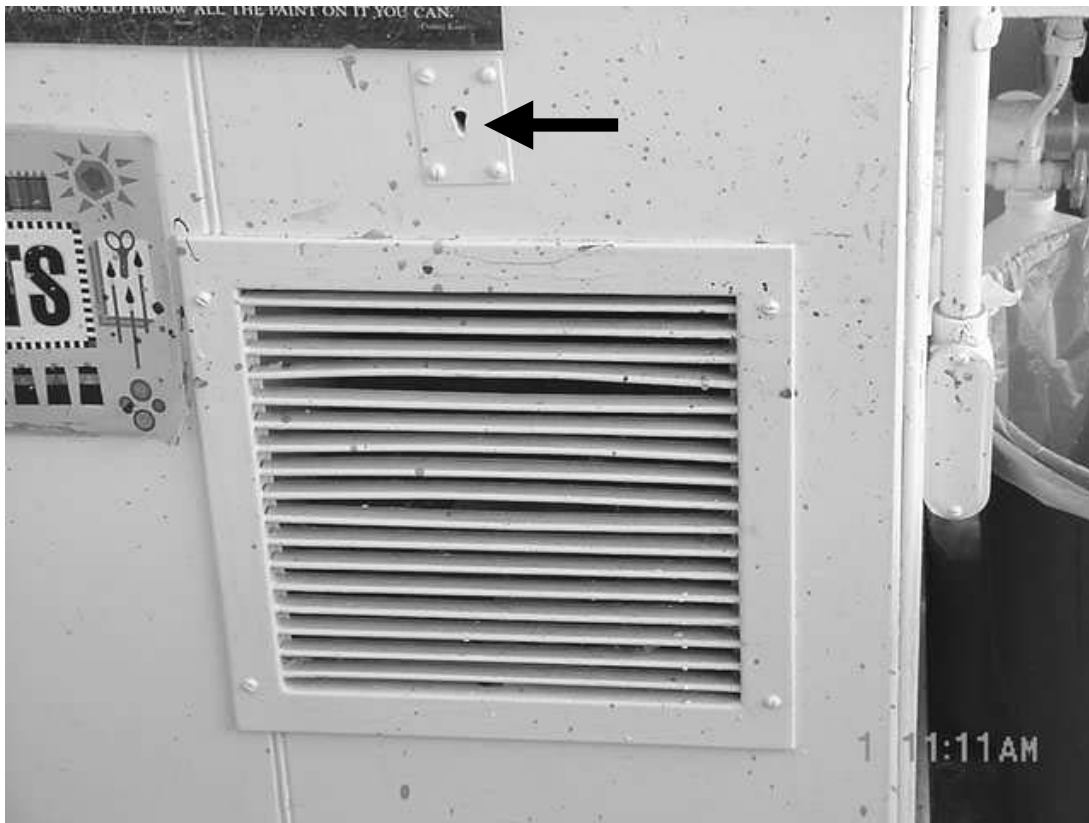
Picture 7

Mechanical exhaust ventilation is provided by wall or ceiling-mounted intake grills connected to ductwork (see Pictures 7 & 8). A number of exhaust vents were not operating and were scheduled for repair by the Upton School Department's heating, ventilation and air conditioning (HVAC) consultant (Johnson Controls, Inc.). Exhaust vents in the original building have internal louvers that are controlled by pull chains to adjust airflow. A few of these vents were missing pull chains (see Picture 7). As with the univents, a number of exhaust vents were obstructed by tables, chairs, boxes and other items (see Picture 9).

Wall-Mounted Exhaust Vent Note Pull Chain Adjusting Interior Louver Missing

2. Continue with plans to have rooftop exhaust motors repaired. Inspect exhaust flues for proper function; repair/replace pull chains as necessary.
3. Once the exhaust systems are operational, consider having the systems balanced by an HVAC engineering firm.

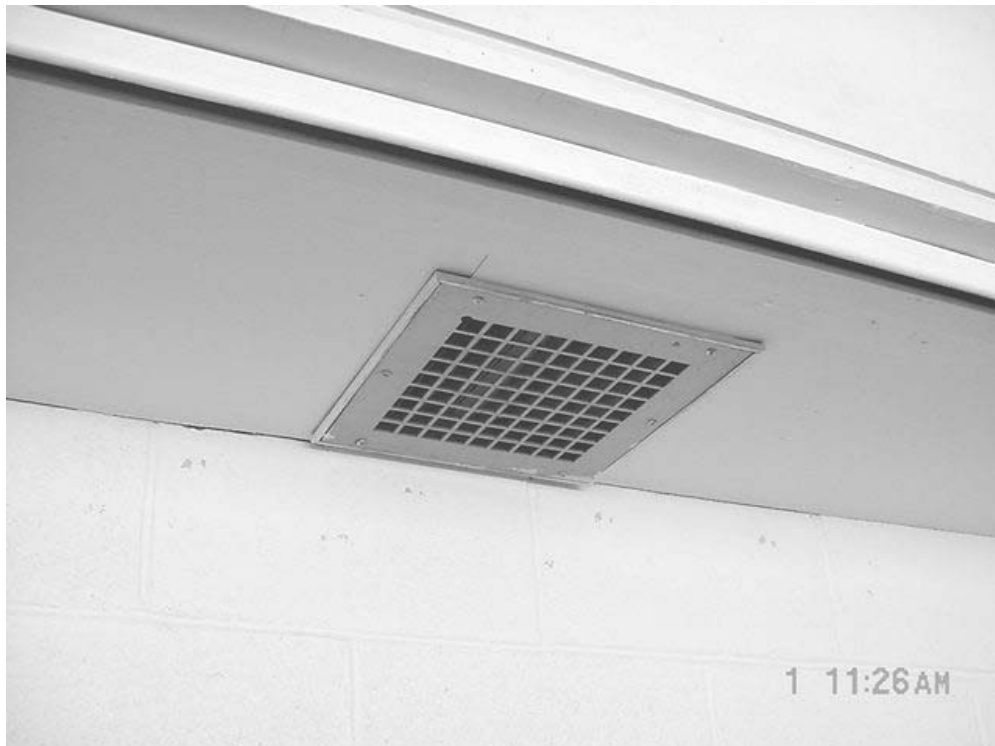
Picture 8

Ceiling-Mounted Exhaust Vent

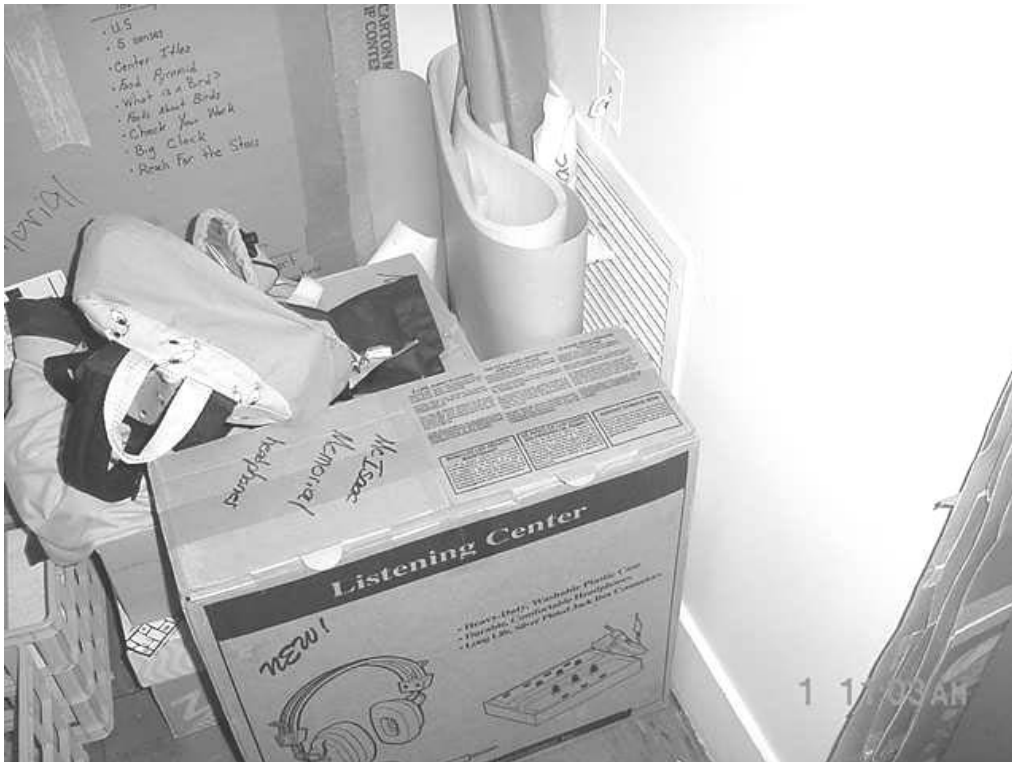
Picture 9

Obstructed Wall-Mounted Exhaust Vent

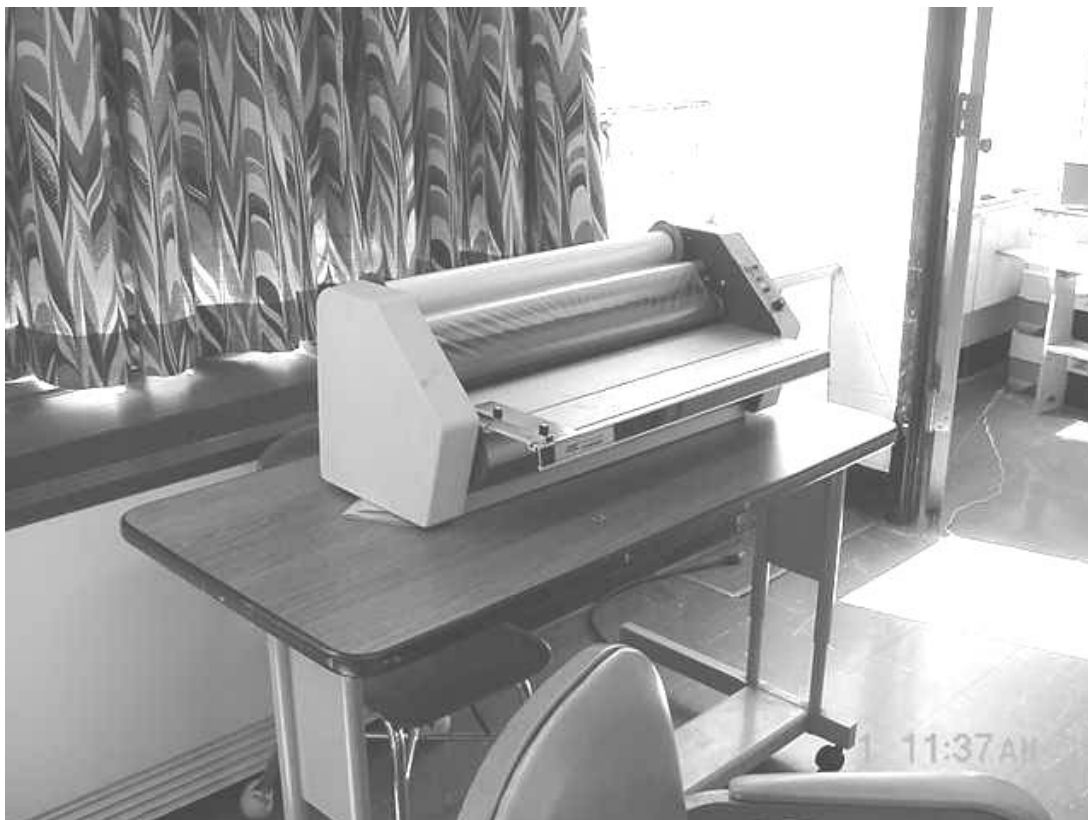
Picture 10

The teacher's workroom contained a lamination machine. Lamination machines can give off heat and odors, particularly if the equipment is older and in frequent use. The lamination machine is stationed directly in front of the univent (see Picture 10), which can

serve to distribute heat and odors throughout the room. The room was subdivided into two areas separated by an approximate 7-8 foot partition. The mechanical exhaust vent for the original room is located in the adjacent room on the far wall. Without mechanical exhaust ventilation, pollutants produced by office equipment can build up and become a potential source of irritation to the eyes, nose and respiratory system.

Lamination Machine in Teacher's Workroom

6. Repair any existing water leaks and replace any remaining water-stained ceiling tiles. Examine the areas above these tiles for microbial growth. Disinfect areas of water leaks with an appropriate antimicrobial as needed.
7. Ensure plants are located away from univents in classrooms. Ensure drip pans are placed underneath plants in classrooms. Examine drip pans periodically for microbial growth and disinfect with an appropriate antimicrobial where necessary.
8. Consider relocating lamination machine in teacher's workroom to an area equipped with local exhaust ventilation.
